Report on air quality comparative testing

Performed by Roberto Draganic using the ISEEE 1.002 In-Field Testing Method

Test machines: LHT #1, #2, and LHT #3

August 14-15, 2020

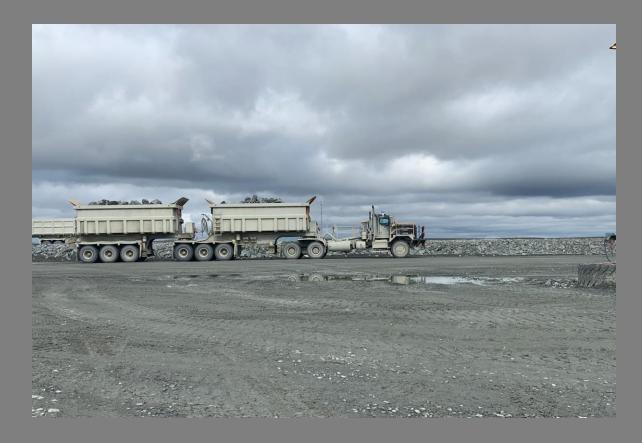
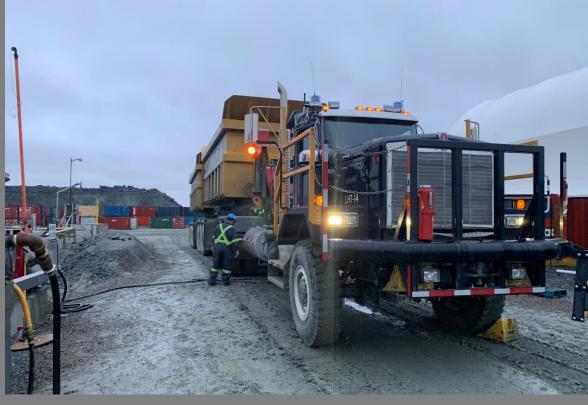
LHT-#2 Nunavut Canada

LHT-#2 modified with

- RESPA®-CF2 Fresh Air Intake
- RESPA®-CFX2 Powered recirculation filtration
- Sy-Klone® Pressure Monitor
